06625 Version 2

Vibration While Driving Under Light Acceleration After Software Update

AFFECTED VEHICLES

Year	Model	Trim	VIN Range
2012–14	CR-V	ALL	ALL

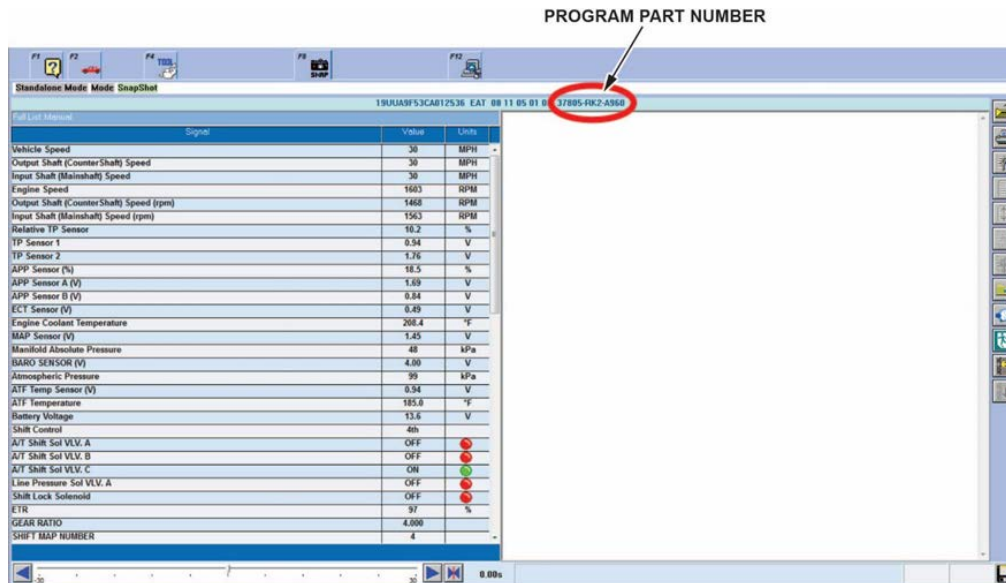
1. Connect the i-HDS, and go to the **AT Data List**. Check to see if the software has been updated by comparing the program P/N against the table below.
