06438 Version 4

Vibration While Driving Under Light AccelerationSupersedes 15-086, dated August 18, 2016, to revise the information highlighted in **yellow**.**AFFECTED VEHICLES**

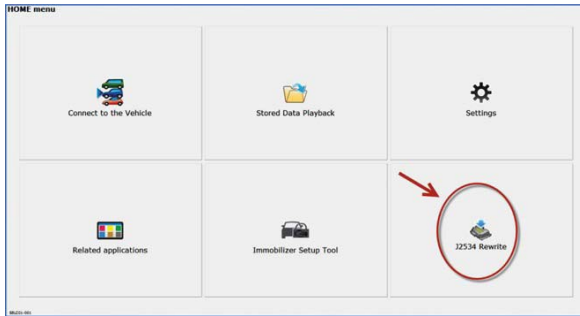
3. Select **J2534 Rewrite**.
