Model	Model Code	Year Model
CR-V	RD8	All
CR-V I-CTDI	RD9	All

Issue Date
19-12-07Originator
Product Technical/QIC
Product Technical/QIC

CR-V Tailgate Hinge Corrosion

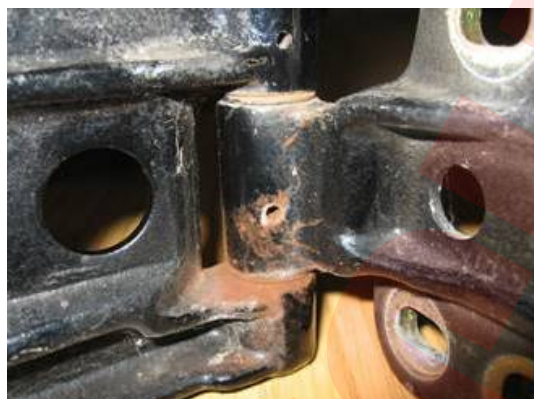
Rusty water coming from the hinge.

Clean and lubricate the hinge assembly as detailed in the repair method section during routine maintenance or on customer complaint.

1. Flush the interior area of the hinge with copious application of WD spray (or equivalent) into both upper, then lower grease holes. Continue until WD spray is ejected from all seams with no evidence of corrosion. (Rotate hinge during process to improve penetration).
2. Flush internal areas of the hinge with copious application of "HHS Clean" (or equivalent) into grease holes to remove all WD content.
3. Clean external surfaces of hinge with "HHS Clean"
4. Wipe down with paper towel and allow HHS clean solvent to evaporate.
5. Inject HHS 2000 (or equivalent) grease into the upper and lower grease holes until grease is ejected from all seams. (Rotate hinge to aid penetration).

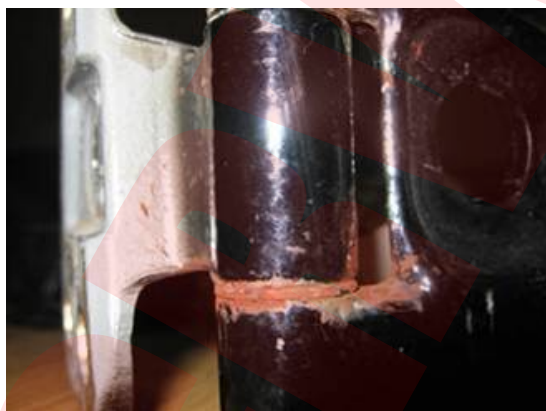
Visible corrosion around the sintered bearings.

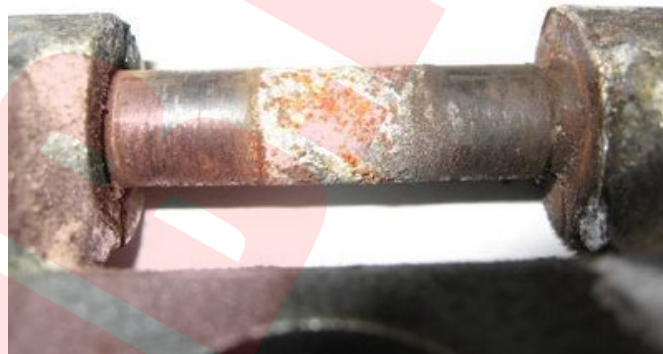
The internal surfaces of the hinge have become dry due to environmental conditions and has corroded.
