Model	Model Code	Year Model	Issue Date 19-12-07
CR-V	RD8	All	Originator Product Technical/QIC Product Technical/QIC
CR-V I-CTDI	RD9	All

## CR-V Tailgate Hinge Corrosion

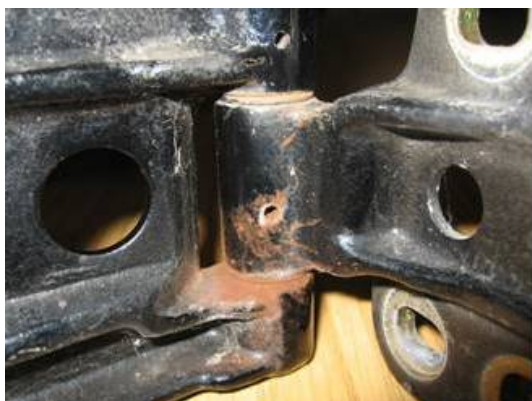
Rusty water coming from the hinge.

Clean and lubricate the hinge assembly as detailed in the repair method section during routine maintenance or on customer complaint.

1. Flush the interior area of the hinge with copious application of WD spray (or equivalent) into both upper, then lower grease holes. Continue until WD spray is ejected from all seams with no evidence of corrosion. (Rotate hinge during process to improve penetration).
2. Flush internal areas of the hinge with copious application of "HHS Clean" (or equivalent) into grease holes to remove all WD content.
3. Clean external surfaces of hinge with "HHS Clean"
4. Wipe down with paper towel and allow HHS clean solvent to evaporate.
5. Inject HHS 2000 (or equivalent) grease into the upper and lower grease holes until grease is ejected from all seams. (Rotate hinge to aid penetration).

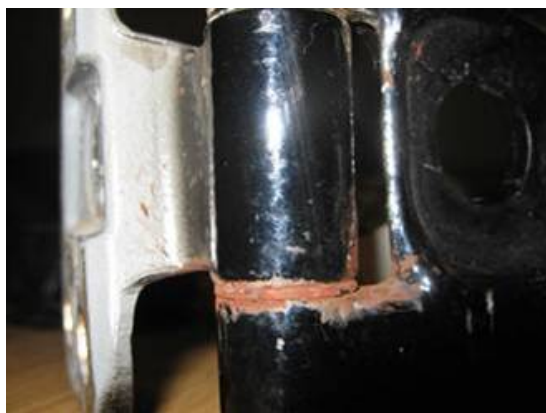
Visible corrosion around the sintered bearings.

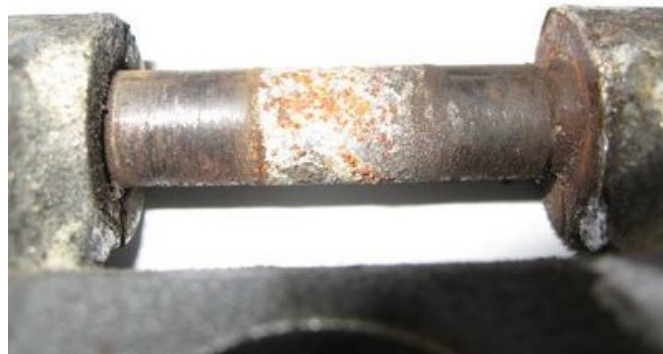
The internal surfaces of the hinge have become dry due to environmental conditions and has corroded.
